# Manhole Inspection Summary

Manhole # S21EE\_012MH

Insp Date: **6/27/07 9:37 AM**

**Location** Address: **1412 FULTON-MONROE**

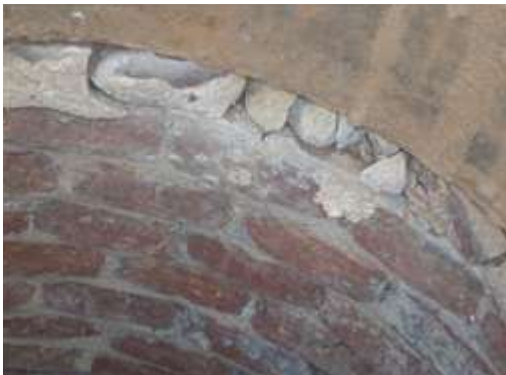
Defect 2

DETERIORATION OF CHIMNEY

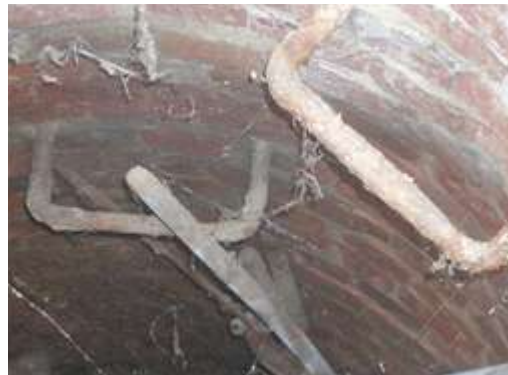
Defect 1

DETERIORATION OF CHIMNEY

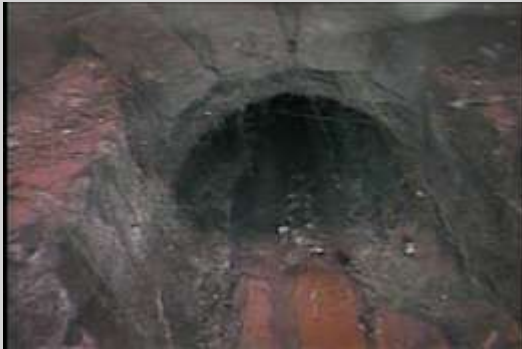
12 O'Clock Outflow

8 in. Circular Gravity Sewer  
Pipe Out @ 12 O'Clock

Pipe Height: **8.4** (in.) Rod and Bar (Angled)  
Pipe Material: **Clay** ☐ Pipe Lined  
Invert Depth: **8.04** (ft.) Flow Characteristics: **Slow**  
Deposits: ☒ None ☐ Mud ☐ Sludge ☐ Debris ☐ Grease  
Silt Depth: (in.) Deposits Extent:  
Infiltration: **None** Pipe Seal Cond: **Roots**

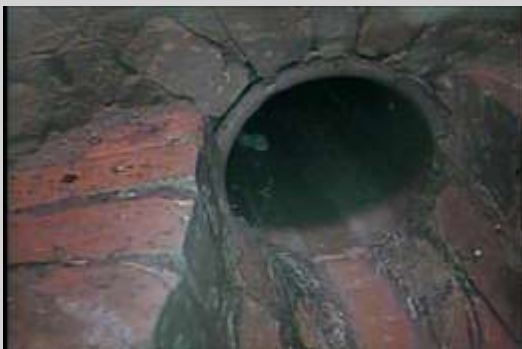
3 O'Clock Inflow

8 in. Circular Gravity Sewer  
Pipe In @ 3 O'Clock

Pipe Height: **8.4** (in.) Rod and Bar (Angled)  
Pipe Material: **Clay** ☐ Pipe Lined  
Invert Depth: **7.75** (ft.) Flow Characteristics: **Slow**  
Deposits: ☒ None ☐ Mud ☐ Sludge ☐ Debris ☐ Grease  
Silt Depth: (in.) Deposits Extent:  
Infiltration: **None** Pipe Seal Cond: **Roots**

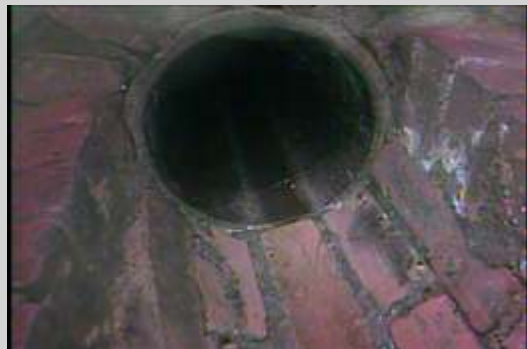
9 O'Clock Inflow

8 in. Circular Gravity Sewer

Pipe In @ 9 O'Clock

Infiltration: **None** Pipe Seal Cond: **Cracked**
